FINAL REPORT OF MINOR COAL OUTBURST DISASTER
NO. 2 MINE
UNITED STATES STEEL COMPANY, COAL DIVISION
GARY, McDOWELL COUNTY, WEST VIRGINIA

February 9, 1953

T. C. Higgins
W. E. Gaylor
J. L. Gilley
Coal-Mine Inspectors

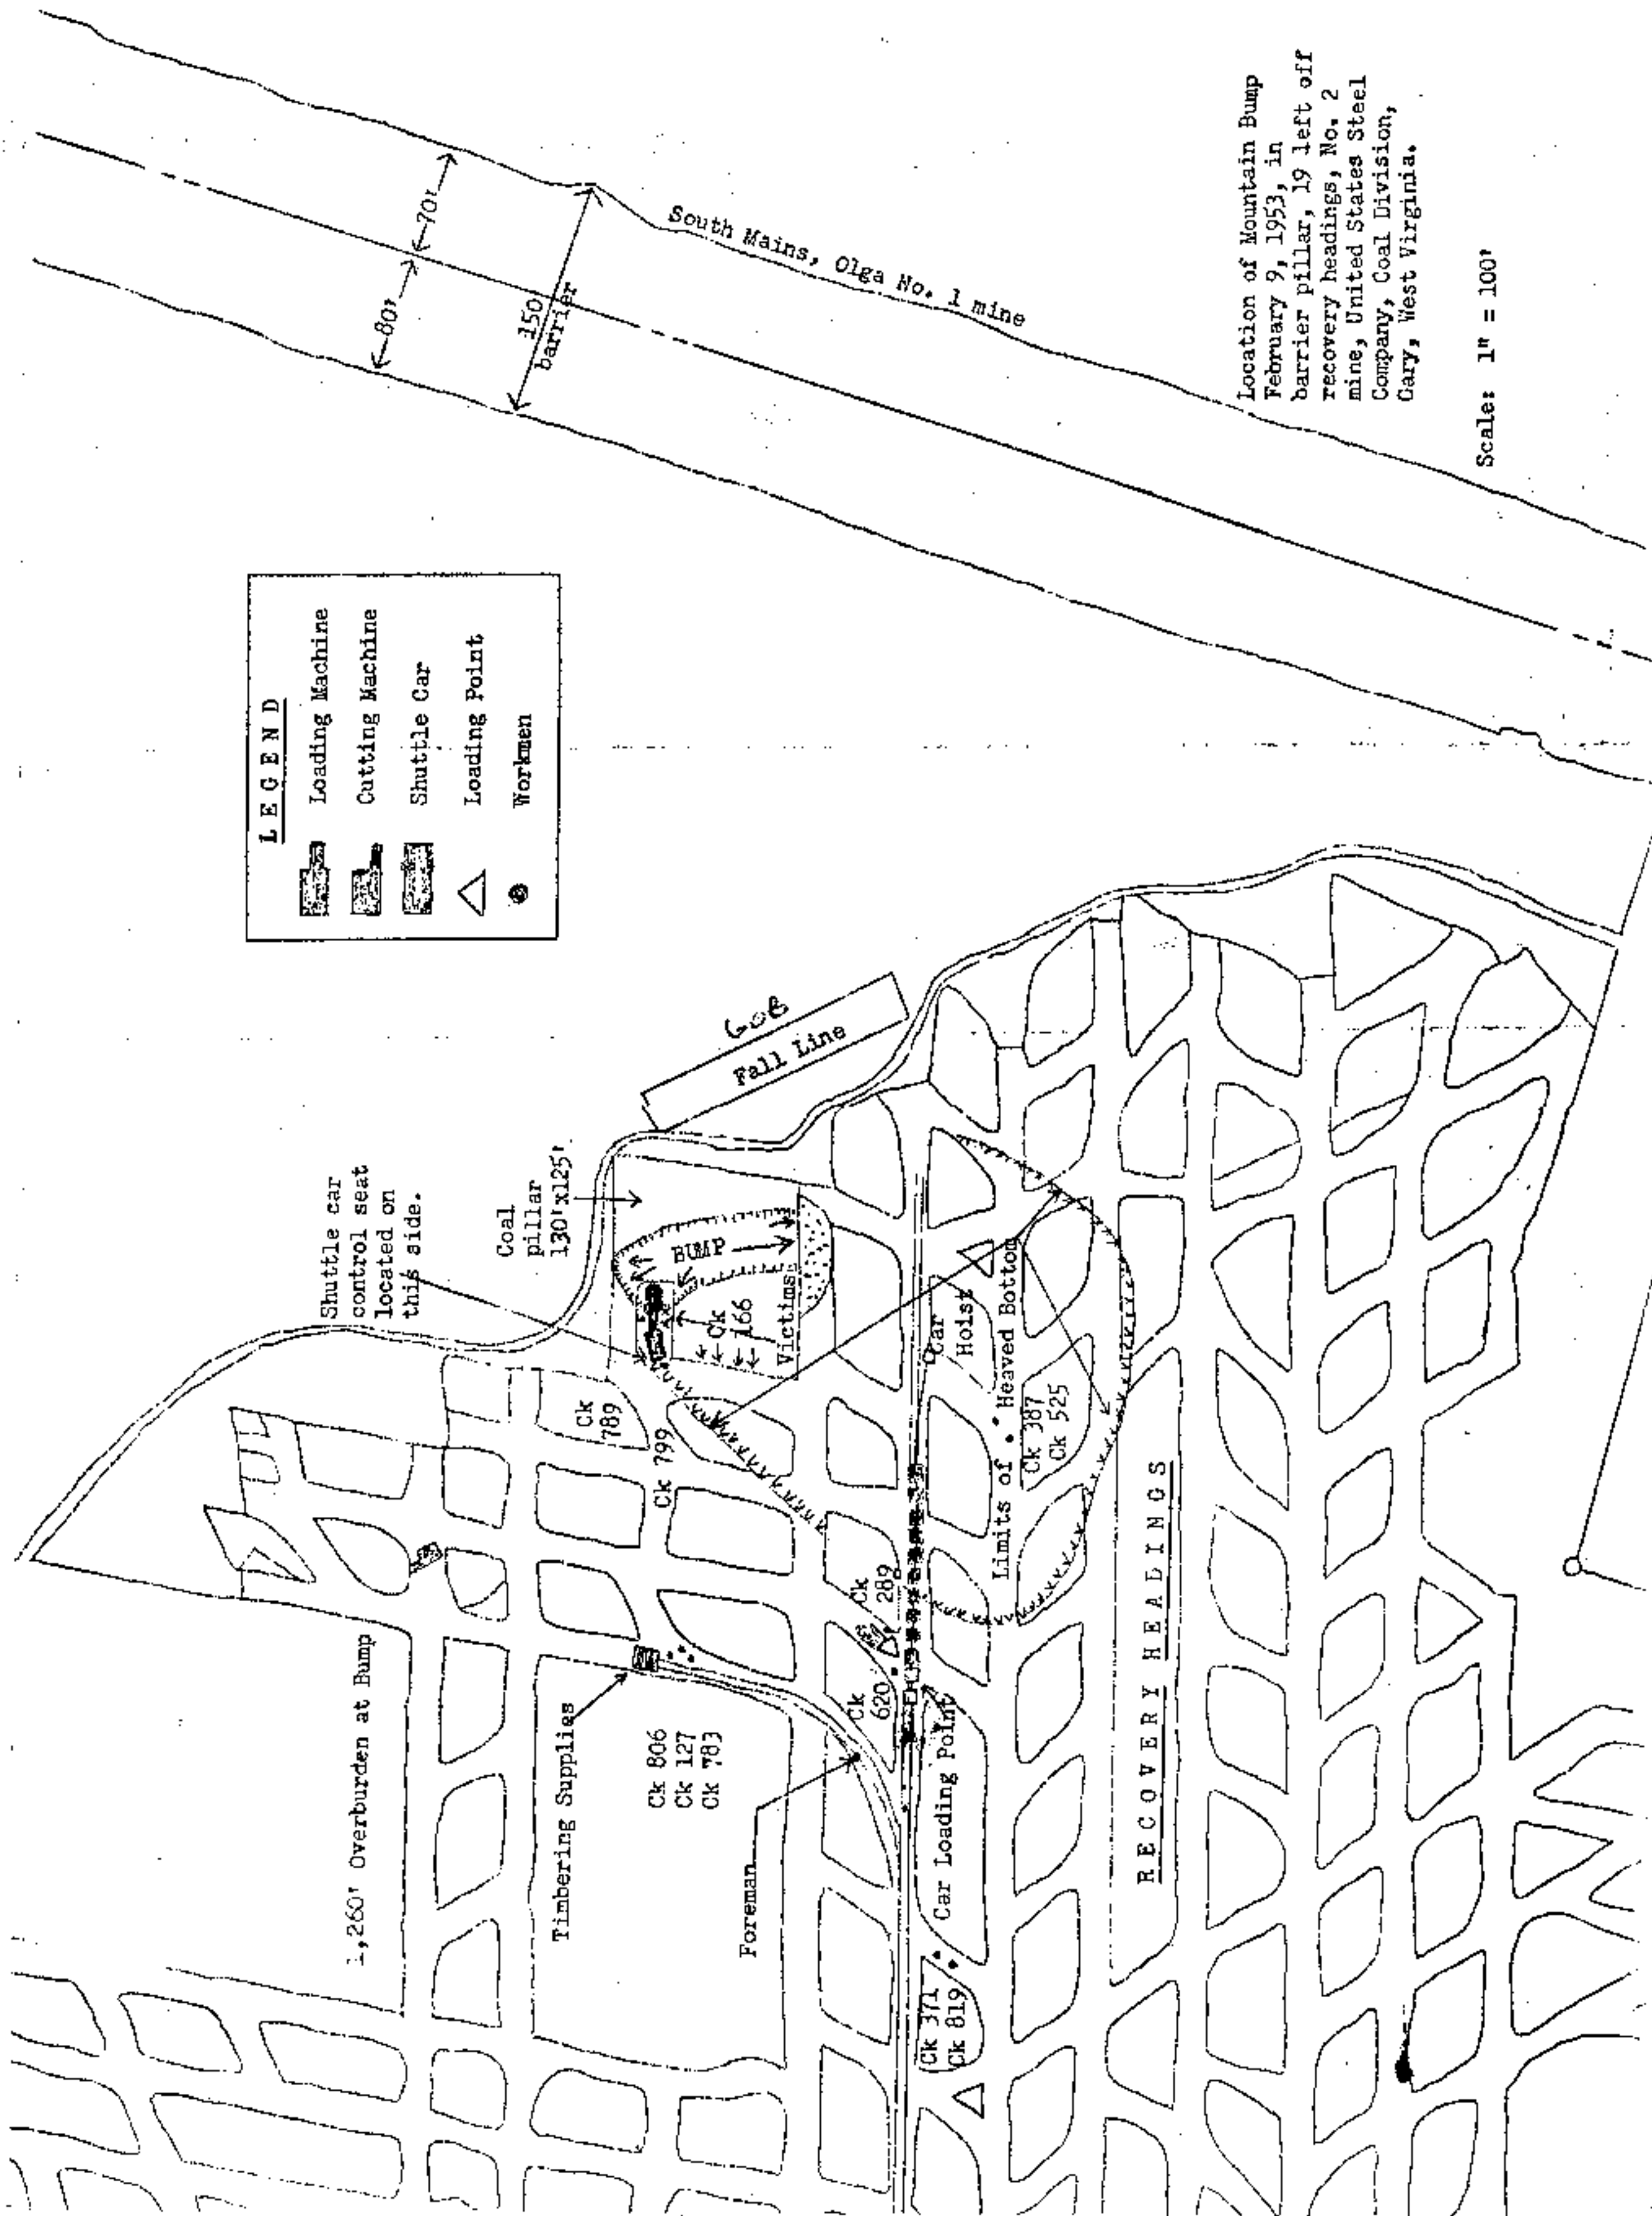
APPENDIX B

As noted in Appendix B, the place was being driven toward the goaf and in proximity to a highly stressed core area of the pillar block and this pillar block, originally approximately 40,000 square feet in area, had been reduced by extraction to approximately 15,625 square feet and was much greater in dimensions than the adjacent pillar blocks fringing the line of extraction. These smaller pillar blocks were individually nearly equal in size. It is not unreasonable to assume that this large block became progressively over-stressed with the focus of stress laterally constrained near the center. The stress wave released by the ultimate failure of this coal pillar was rather intense. The forces were concentrated in the room opening and extended laterally and in a diagonal direction through the block to the No. 1 recovery airway (see Appendix B). The forces released in the room were sufficiently intense to shear the loading head and conveyor section from the caterpillar unit of the loading machine and

Investigation of the pillar line revealed that extensive caving in the goaf evidently occurred soon following extraction of coal. The roof break line extended reasonably close to the line of extraction, even though the pillar line was irregular with points projecting into the mined-out area, as shown in Appendix B.

A large coal pillar block was next to the line of extraction and it was flanked on three sides by coal pillars much smaller in size. This large coal pillar had not been developed, prior to its becoming part of the extraction line, comparable in dimensions and shape to surrounding pillar blocks so as to prevent concentration of forces induced by the retreating abutment upon individual pillars. This large coal pillar was partly projecting into the mined-out area, thus accepting the major portion of the load. A room, which in effect was a pillar pocket, was being driven into this large coal pillar, located in the abutment area, directly toward the goaf and in proximity to the stressed core of the pillar.

Location of Mountain Bump
February 9, 1953, in
barrier pillar, 19 left off
recovery headings, No. 2
mine, United States Steel
Company, Coal Division,
Gary, West Virginia.

1. Coal pillars should be developed as nearly uniform in dimensions and in shape as practicable and sufficiently in advance (500 feet or more) of the retreating pillar line. In any case, development should be sufficiently in advance of the progressive outward movement of the abutment load so as to minimize concentration of stress on individual pillars.

3. Mining projections in the future should be planned to eliminate the practice of having large blocks of coal, which in comparison are much greater in dimensions than surrounding pillars, within the abutment area of the retreating pillar line.

4. The coal pillars should be recovered by the open-end pocket method, and no splitting of pillars or other secondary development should be done within the abutment area. Places should not be driven toward the goaf in highly stressed pillar blocks.

5. Pillars should be extracted in a manner that will not leave major points projecting into the gob.
6. Mining conditions throughout this mine should be examined and practices that could induce outbursts should be eliminated.
